**Job Name:** Quick Mount PV On-Call Lab Testing  
Walnut Creek, CA

**Subject:** Quick Mount PV Load Testing - L-Mount with QMPV Dual Drive Structural Screw  
[QMPV# 20170517-Revision E]

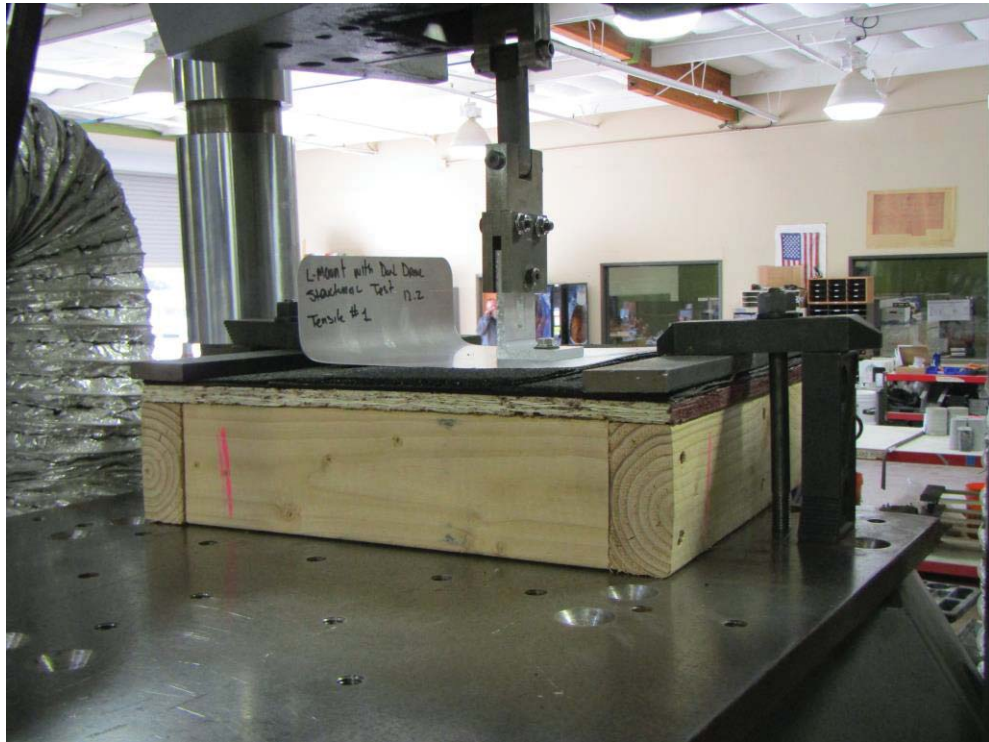
Photo 1: Tensile Load (pre-test)

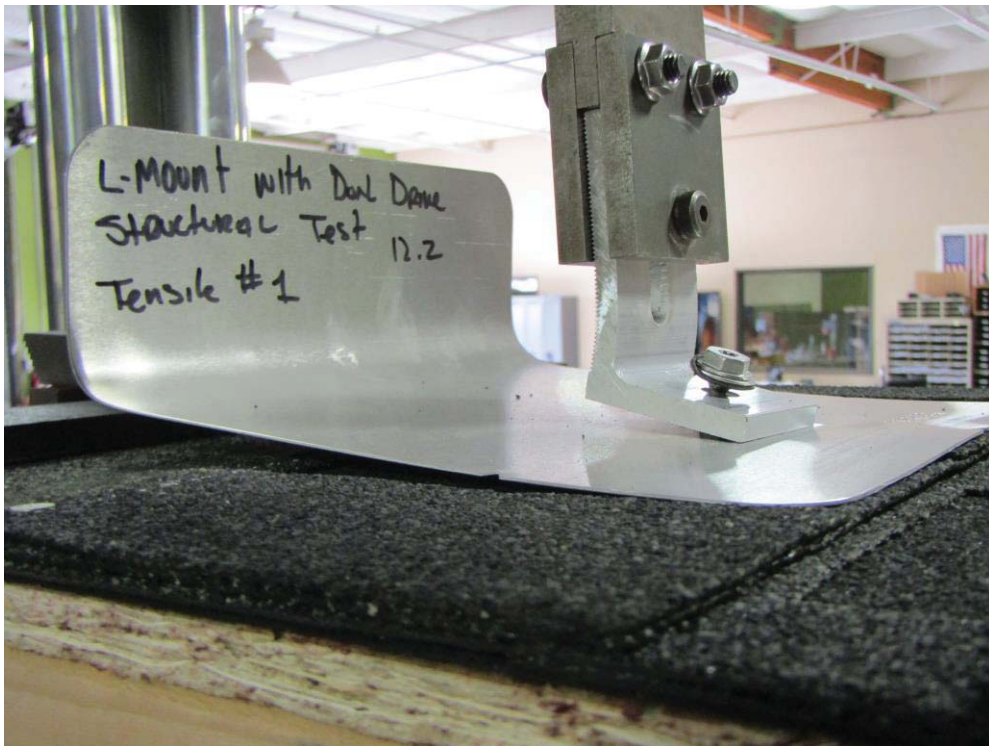
Photo 2: Tensile Load (post-test)

Sample Number	Rafter Specific Gravity at Moisture	Test Rafter Moisture Content [%]	Peak Load [lbs]	Deflection at Peak Load [in]	Failure Mode
DDSS.T1	0.4598	12.2	2620	0.7175	Lag Screw Pull Out
DDSS.T2	0.4513	12.7	1982	0.418	Lag Screw Pull Out
DDSS.T3	0.4997	13.0	2531	0.5377	Lag Screw Pull Out
DDSS.T4	0.4563	12.7	2314	0.5167	Lag Screw Pull Out
DDSS.T5	0.4561	12.2	2508	0.5138	Lag Screw Pull Out
DDSS.T6	0.4628	12.7	2314	0.4300	Lag Screw Pull Out
Average			2378

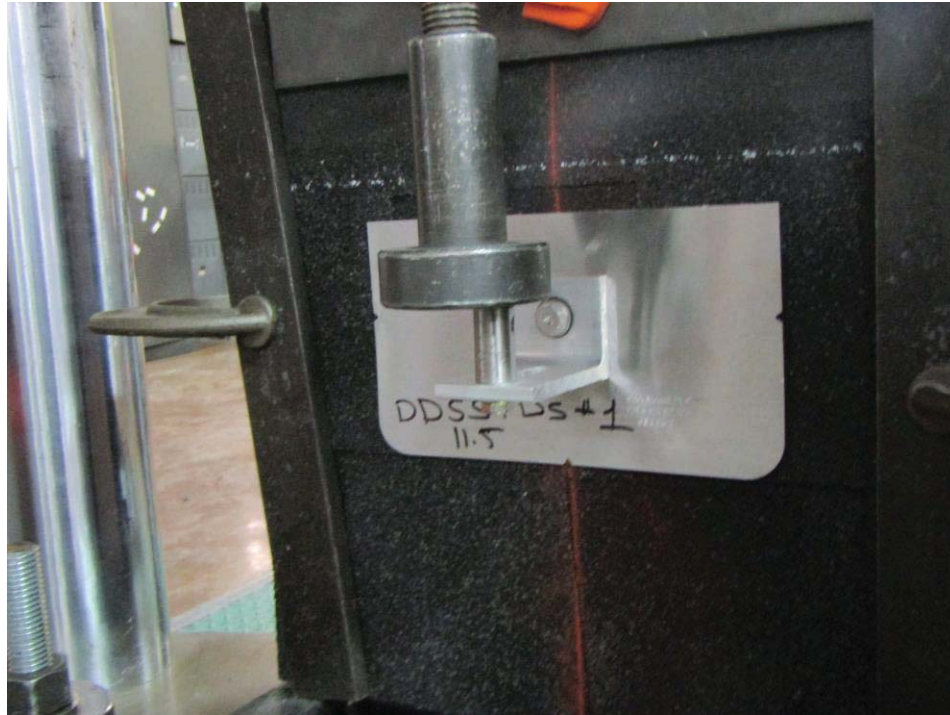
Photo 3: Lateral Parallel to Rafter Eccentric Load (pre-test) - Downslope

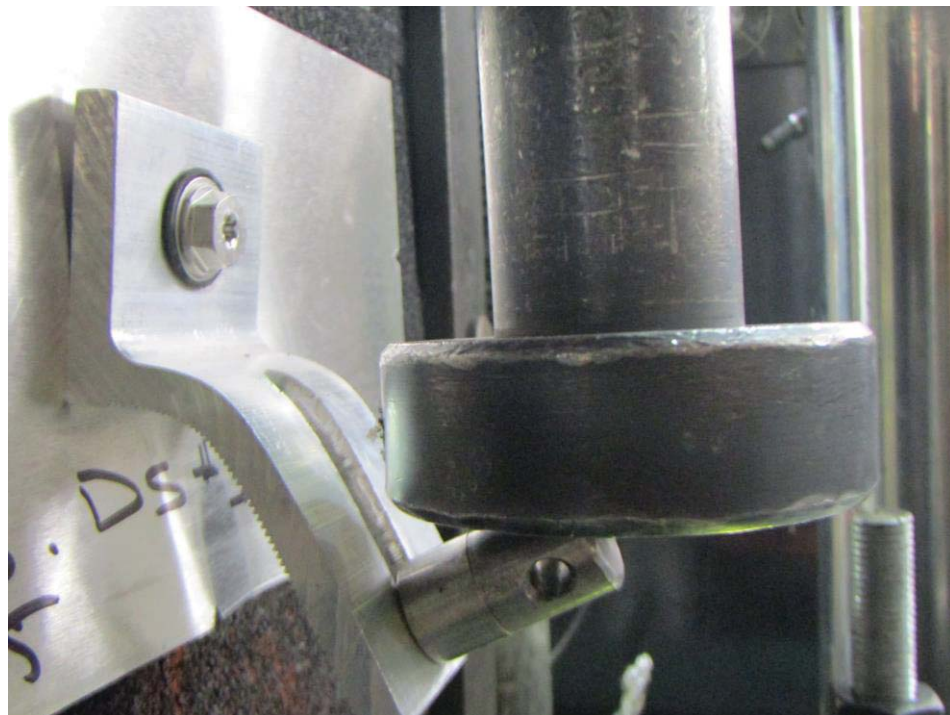
Photo 4: Lateral Parallel to Rafter Eccentric Load (post-test) - Downslope

Sample Number	Rafter Specific Gravity at Moisture	Test Rafter Moisture Content [%]	Peak Load [lbs]	Deflection at Peak Load [in]	Failure Mode
DDSS.DS1	0.5903	11.5	651	0.7545	L-Foot Bending (Al Ductile)
DDSS.DS2	0.6142	12.2	655	0.7918	L-Foot Bending (Al Ductile)
DDSS.DS3	0.6115	12.0	633	0.7419	L-Foot Bending (Al Ductile)
DDSS.DS4	0.6281	11.2	618	0.8200	L-Foot Bending (Al Ductile)
Average			639

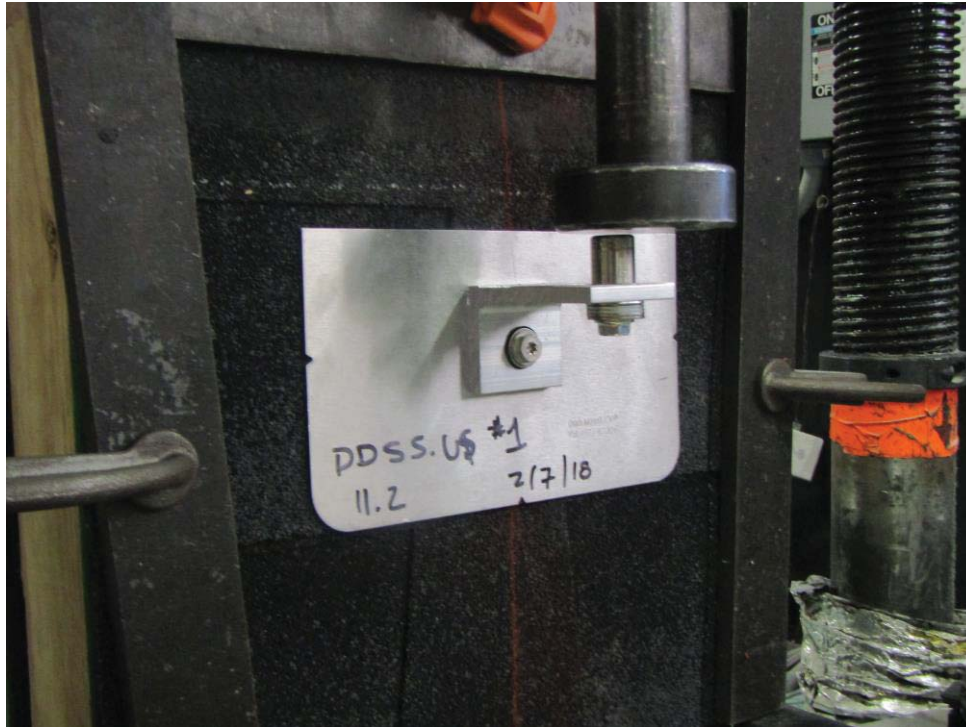
Photo 5: Lateral Parallel to Rafter Eccentric Load (pre-test) - Upslope

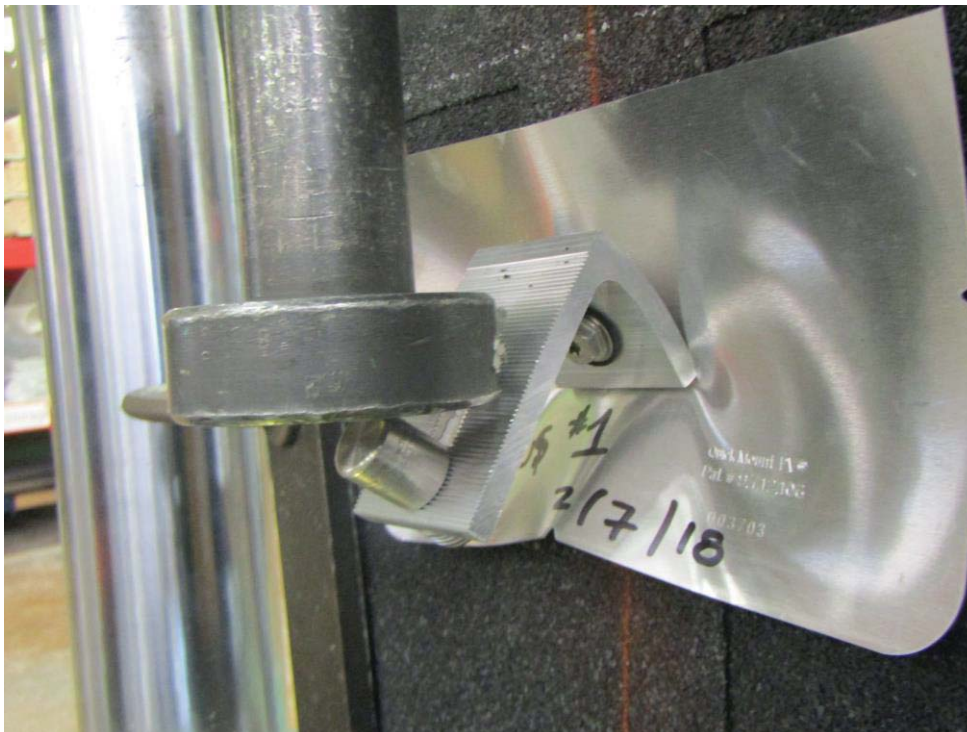
Photo 6: Lateral Parallel to Rafter Eccentric Load (post-test) - Upslope

Sample Number	Rafter Specific Gravity at Moisture	Test Rafter Moisture Content [%]	Peak Load [lbs]	Deflection at Peak Load [in]	Failure Mode
DDSS.US1	0.5804	11.2	818	3.7510	Flashing Puncture/Lag Screw Pull Out
DDSS.US2	0.5947	12.1	676	4.5083	Flashing Puncture/Lag Screw Pull Out
DDSS.US3	0.6180	11.5	696	3.8030	Flashing Puncture/Lag Screw Pull Out
DDSS.US4	0.6277	11.6	696	3.9598	Flashing Puncture/Lag Screw Pull Out
DDSS.US5	0.5546	12.0	826	4.5253	Flashing Puncture/Lag Screw Pull Out
Average			742

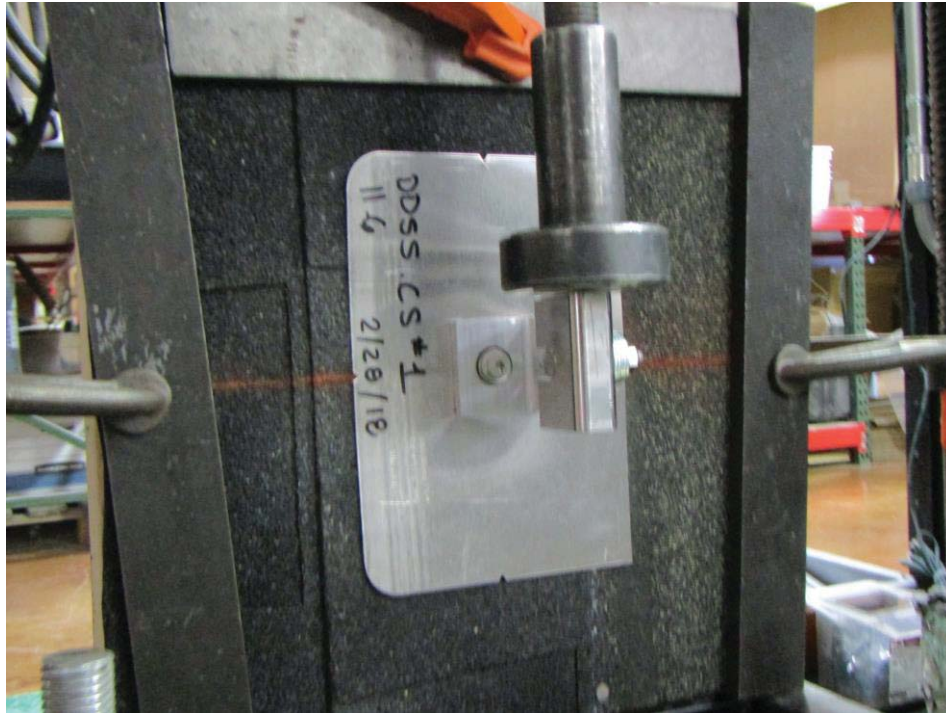
Photo 7: Lateral Perpendicular to Rafter Eccentric Load (pre-test) – Block Inside

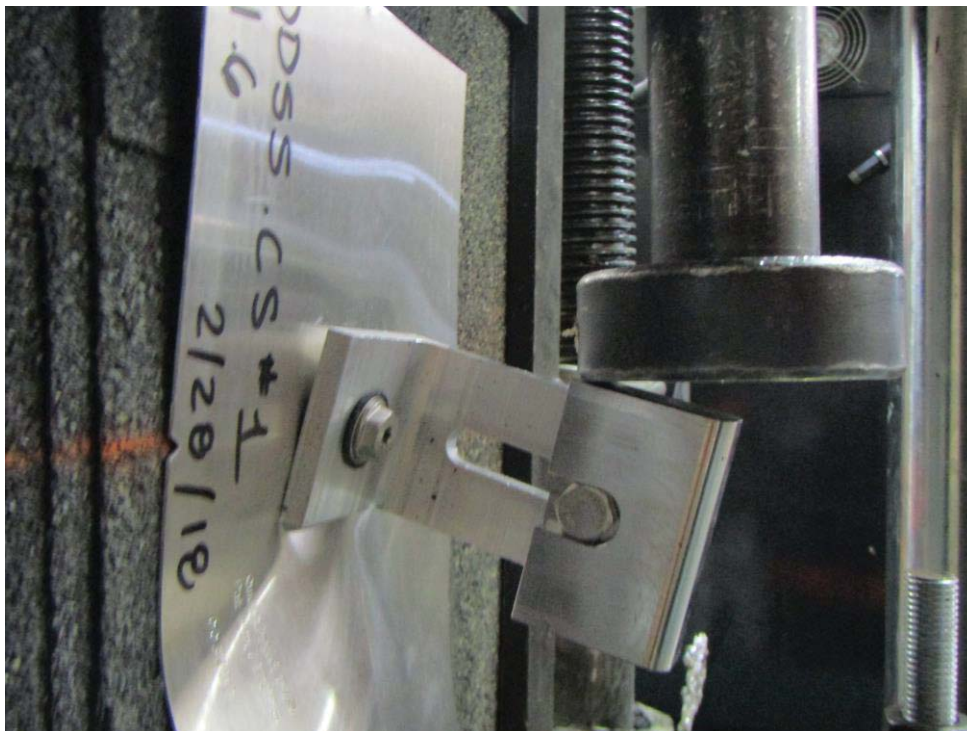
Photo 8: Lateral Perpendicular to Rafter Eccentric Load (post-test) – Block Inside

Sample Number	Rafter Specific Gravity at Moisture	Test Rafter Moisture Content [%]	Peak Load [lbs]	Deflection at Peak Load [in]	Failure Mode
DDSS.CS1	0.4480	11.6	713	1.0842	Flashing Puncture/Lag Screw Pullout
DDSS.CS2	0.4460	11.8	720	0.9852	Flashing Puncture/Lag Screw Pullout
DDSS.CS3	0.4546	11.3	652	0.7872	Flashing Puncture/Lag Screw Pullout
DDSS.CS4	0.6196	11.3	827	1.1642	Flashing Puncture/Lag Screw Pullout
DDSS.CS5	0.5669	11.4	928	1.2199	Flashing Puncture/Lag Screw Pullout
Average			768
