# Quality Assurance Report

TÜVRheinland® Report 21276144\_001

This test was requested by the Fire Services to demonstrate that, once activated into shut-down mode, the IMO FireRaptor would sustain solar panel isolation at zero volts even when exposed to an open flame with an incremental temperature increase to above 700°C (in accordance with DIN EN 60695-11-3) and eventual destruction of the unit.

<b>Prüfbericht-Nr.:</b> <i>Test Report No.:</i>	<b>21276144_001</b>	<b>Auftrags-Nr.:</b> <i>Order No.:</i>	<b>3227705</b>	Seite 1 von 5 <i>Page 1 of 5</i>	
<b>Kunden-Referenz-Nr.:</b> <i>Client Reference No.:</i>	<b>42441 / 24.07.2017</b>	<b>Auftragsdatum:</b> <i>Order date:</i>	<b>24.07.2017</b>		
<b>Auftraggeber:</b> <i>Client:</i>	<b>IMO Precision Controls Ltd.</b> 1000 North Circular Road, London , GB				
<b>Prüfgegenstand:</b> <i>Test item:</i>	<b>FireRaptor Rapid Shutdown System Unit</b>				
<b>Bezeichnung / Typ-Nr.:</b> <i>Identification / Type No.:</i>	<b>FRS-01</b>				
<b>Auftrags-Inhalt:</b> <i>Order content:</i>	<b>Part Testing according to manufacturer's test procedure</b>				
<b>Prüfgrundlage:</b> <i>Test specification:</i>	<b>No Test specification used</b>				
<b>Warenein

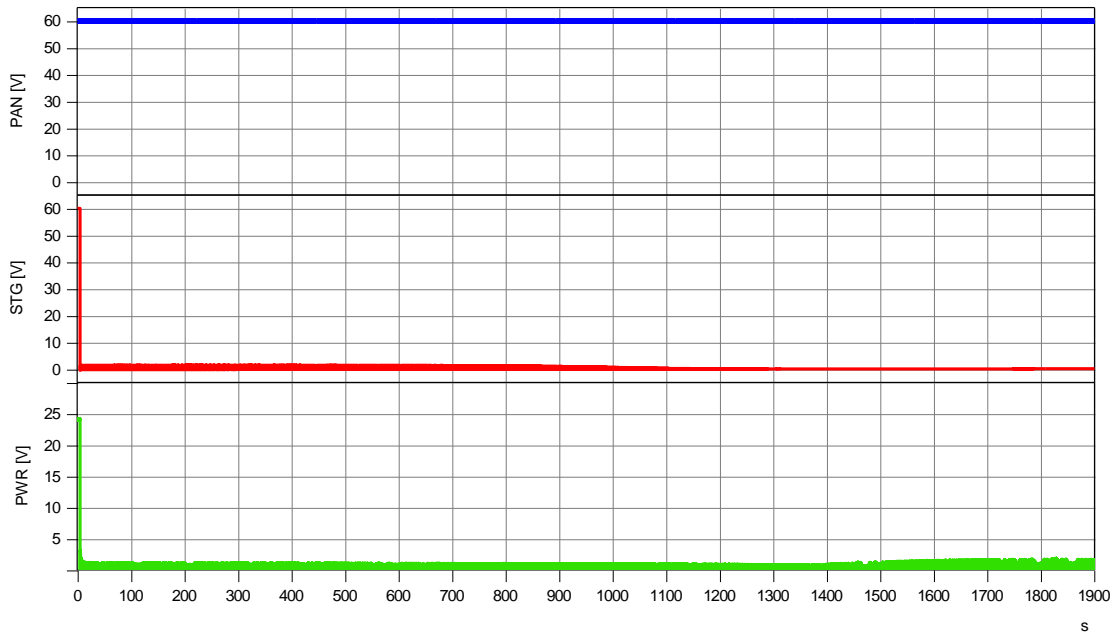
Diagram 1:

Remark	t <sub>1</sub> [s]	t <sub>2</sub> [s]	surface temperature [°C]	flame influence duration [s]
PWR on	0	5	26 (at starting point)	--
PWR off	5	1900	26	--
flame influence 1	10	35	120	25
flame influence 2	135	160	140	25
flame influence 3	190	215	150	25
flame influence 4	235	260	250	25
flame influence 5	290	315	250	25
flame influence 6	350	375	230	25
flame influence 7	410	445	230	35
flame influence 8	490	525	230	35
flame influence 9	560	605	220	45
flame influence 10	630	675	220	45
flame influence 11	690	750	220	60
flame influence 12	800	1900	--	1100

- Test procedure stopped at 1900 seconds, due to destroyed unit. See also picture 25 of photo documentation (21276144\_001\_atm1).
- During the test (between 5 seconds and 1900 seconds) the output STG was not active.

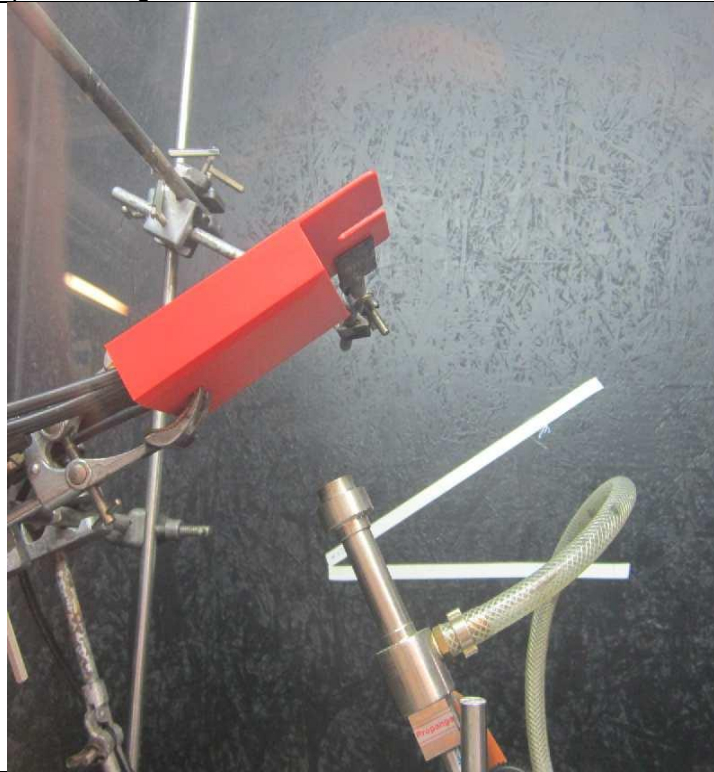
Bild / Picture 11: Test setup in burning chamber

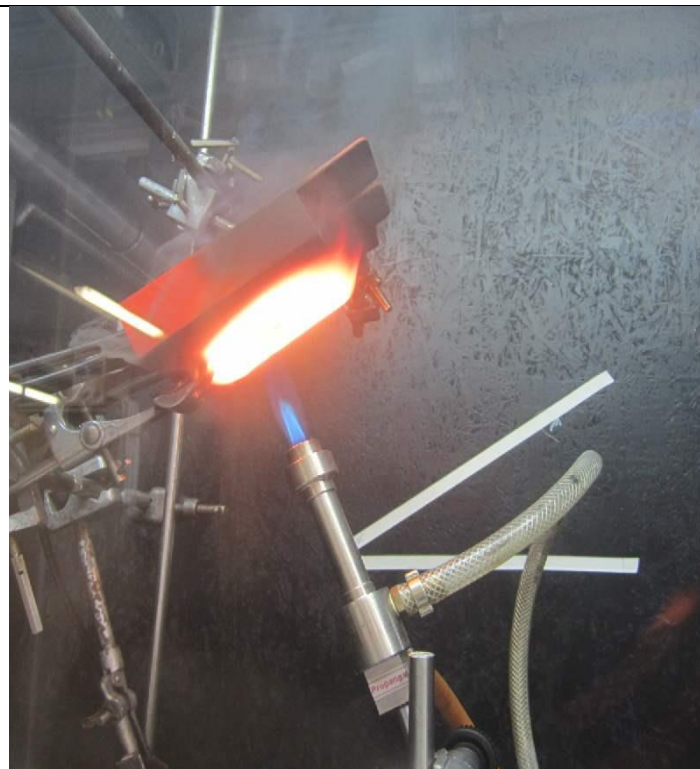
Bild / Picture 12: Fist flame influence

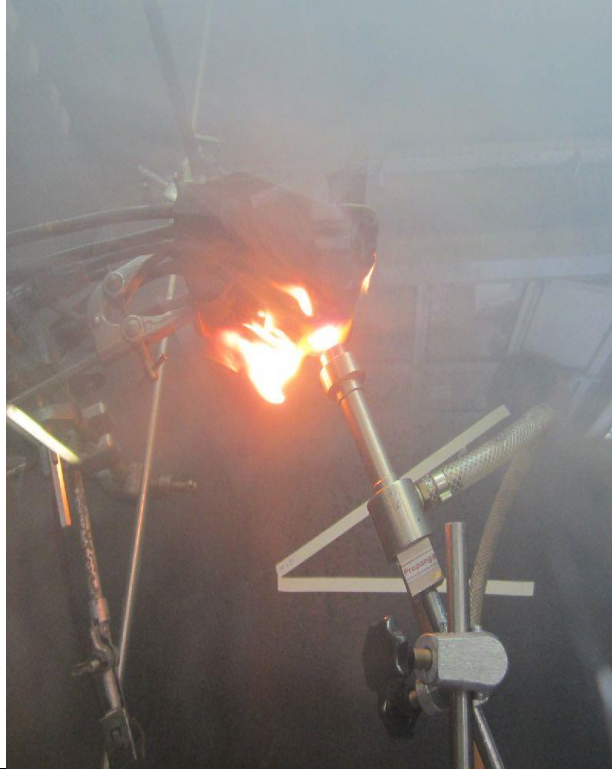
Bild / Picture 25: FRS-01 shortly before the end of the test

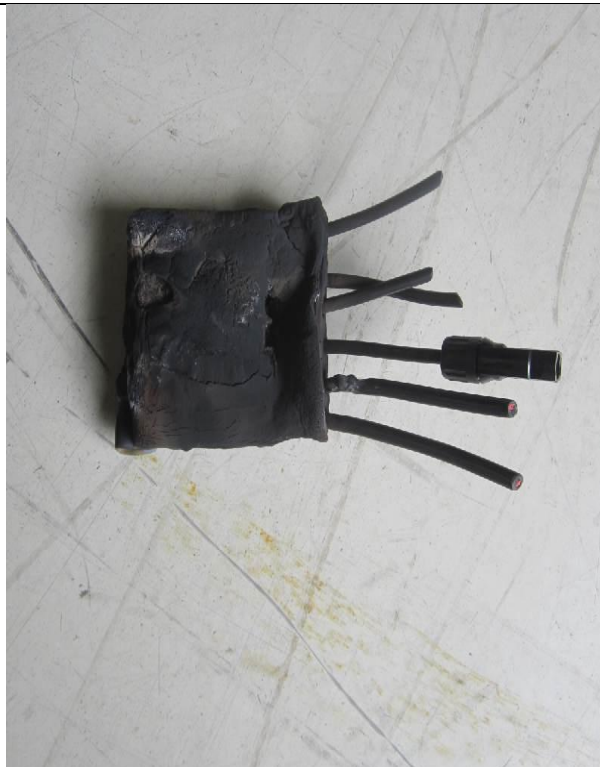
Bild / Picture 26: FRS-01 at the end of the test

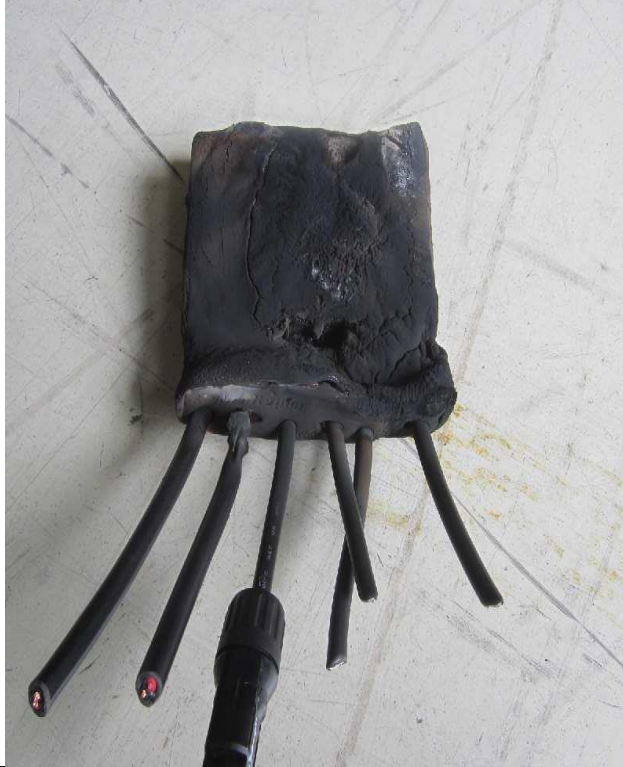
Bild / Picture 27: FRS-01 at the end of the test

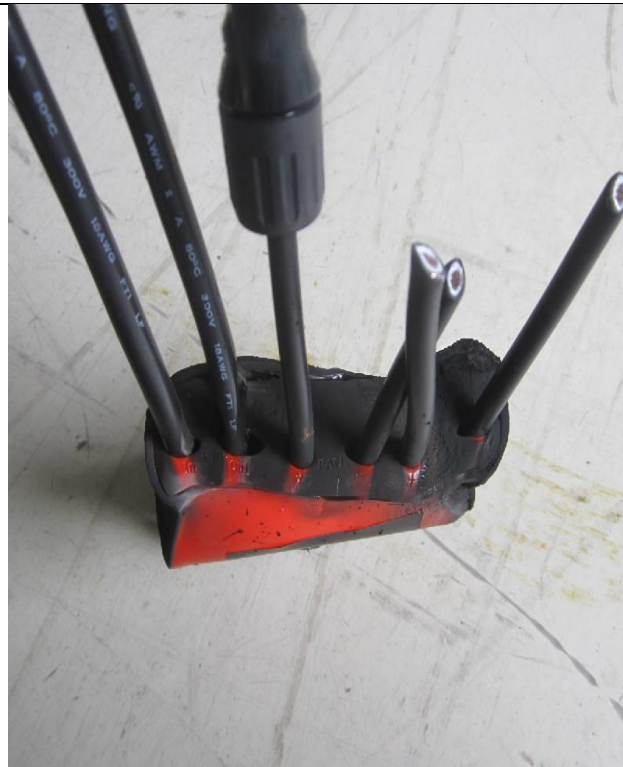
Bild / Picture 28: FRS-01 at the end of the test

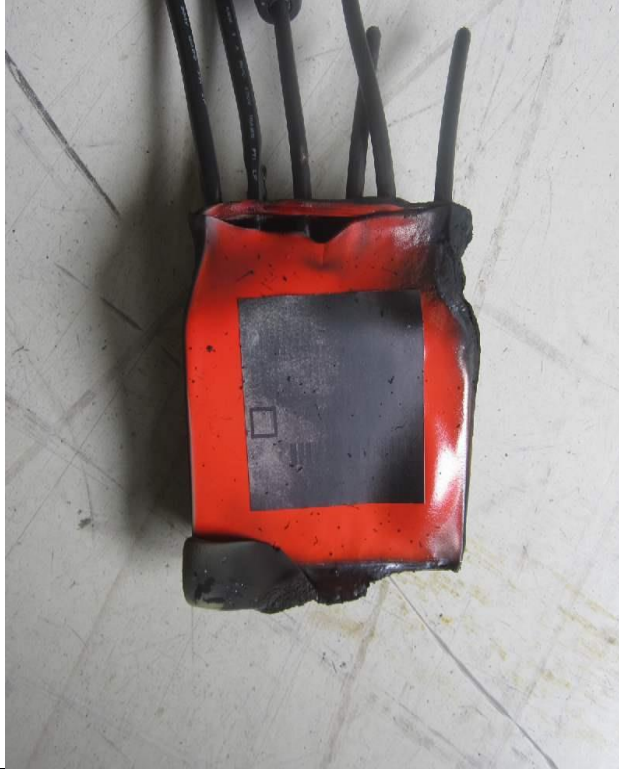
Bild / Picture 29: FRS-01 at the end of the test

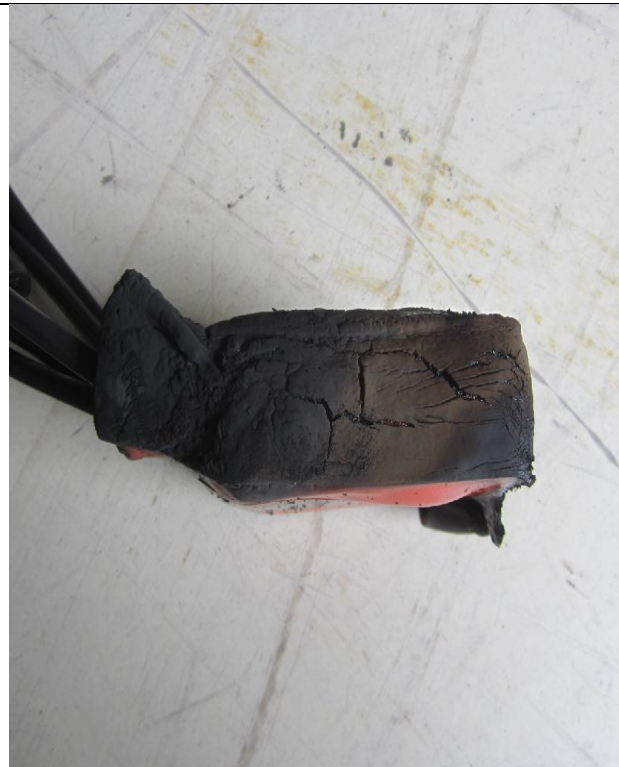
Bild / Picture 30: FRS-01 at the end of the test

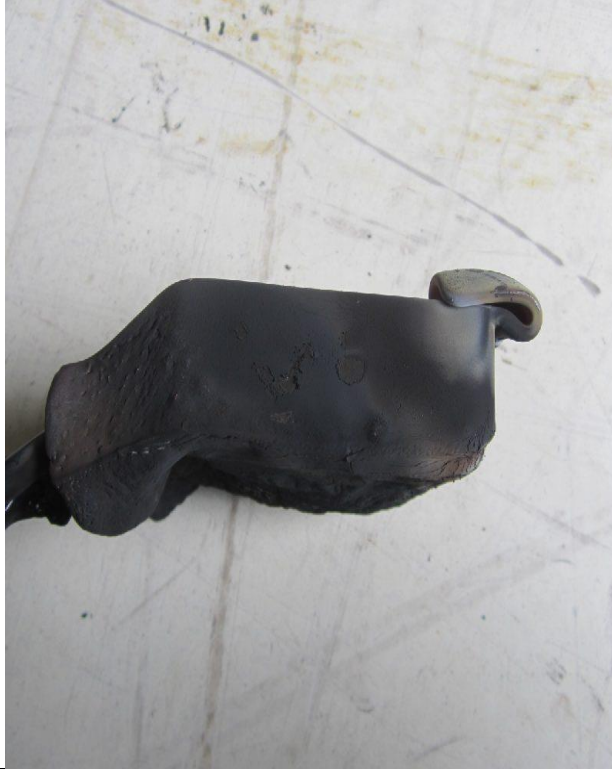
Bild / Picture 31: FRS-01 at the end of the test
