Change Logs Galvo / Symo / Primo / Eco

Inhaltsverzeichnis / Table of contents

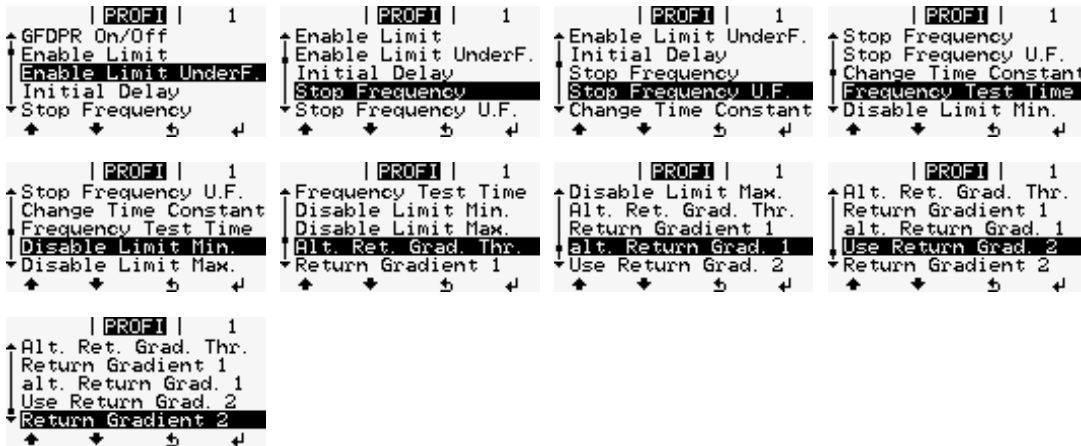
- / Extension of the P (f) settings for the GDPR function by the following parameters:
- / Start frequency at underfrequency
- / Stop frequency at overfrequency
- / Stop frequency at underfrequency
- / Frequency Test Time (Duration of frequency monitoring before return to nominal power)
- / Disable Limit min (lower limit for frequency monitoring)
- / Alternative Return Gradient Threshold (Percentage drop of nominal power, from which “
- / Alternative Return Gradient 1“ is activated)
- / Alternative Return Gradient 1 (Alternative return gradient to maximum power in %/s, based on the difference between frozen and lowest power)
- / Use Return Gradient 2 Mode (Mode: 0 ... ‘Return Gradient 1’ or ‘Return Gradient 1 Alternative’ is used, 1‘Return Gradient 2’ is used)
- / Return Gradient 2 (Further return gradient to the maximum power in %/s, based on nominal power, if this is activated)

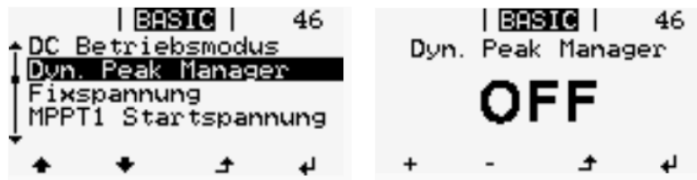
- / Implementation of the Dynamic Peak Manager:
The Dynamic Peak Manager searches the PV curve every 10 minutes for new operating points. This can lead to an increase in earnings, e.g. in shaded plants.
The Dynamic Peak Manager is only implemented and selectable in the country setups 50 Hz, AT1, AT2, AT3, AU, CH, DE1, DE2 and DE3 in the inverters Fronius 3.0-3 Symo S - S 4.5-3.
At the inverters Fronius Symo 3.0-3 M - 8.2-3 M the Dynamic Peak Manager is implemented and selectable in all country setups .

IMPORTANT! To activate the Dynamic Peak Manager subsequently, after the update the country setup must be re-selected and the mode in the Basic service menu must be set from "OFF" to "ON".
