Project Number 114490C

Subject: Laboratory Load Test of the QMHSS with 6061 Base Plate

As requested, Applied Materials & Engineering, Inc. (AME) has completed load-testing the QMHSS hardware. The purpose of our testing was to evaluate the tensile (uplift), compression, and lateral (perpendicular and parallel to rafter) load capacity of the QMHSS attached to a 2"x4" Douglas Fir rafter using two 5/16"Ø x 3.5" lag bolts .

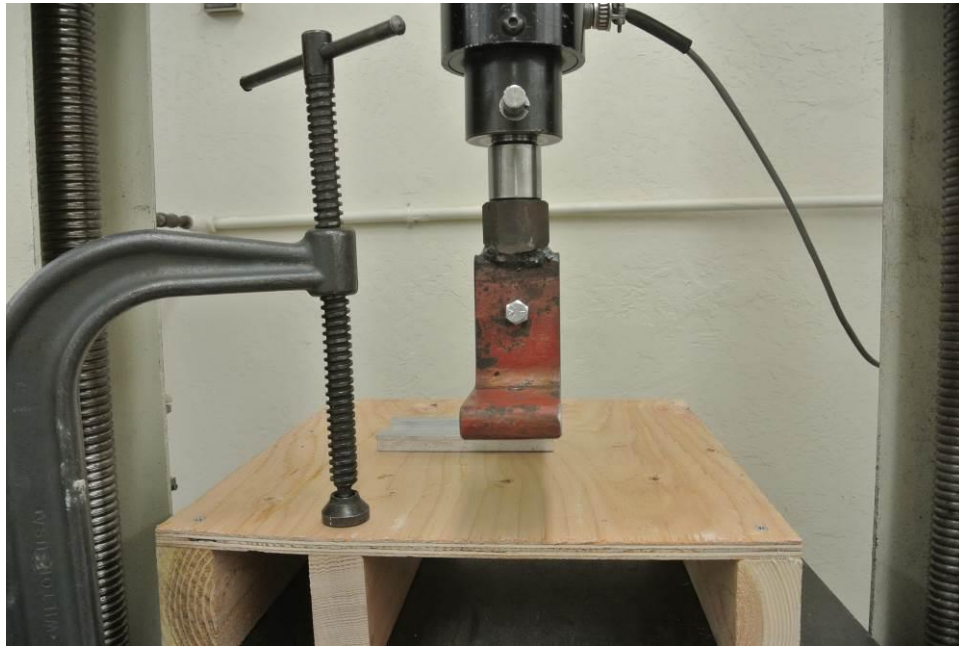
Figure 1a. Test Setup

FIGURE 1
QMSS- 6061 BASE PLATE
COMPRESSIVE LOAD TEST SETUP
PROJECT NUMBER 114490C

A total of six tests were conducted for compressive load capacity on January 17th, 2015 using a United Universal testing machine. Samples were rigidly attached to the testing machine and a compressive load was applied to the hook. The samples were loaded in compression at a constant rate of axial deformation of 0.09 in. /min. without shock until the hook was bent and came in contact with the test board; displacement at maximum load was recorded. Based on the above testing, the average maximum compression load of the QMHSS attached to a 2"x4" Douglas Fir rafter using two 5/16"Ø x 3.5" lag bolts was determined to be 765 lbf. Detailed results are provided in Table I. Test setup and mode of failure are provided in Appendix B, Figure 1.

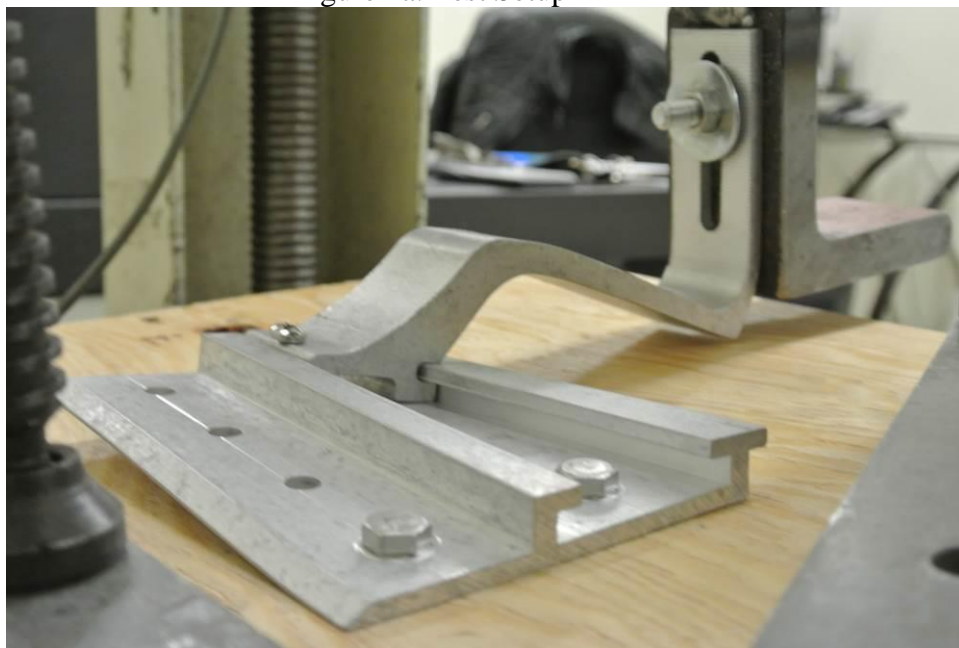
Figure 1b. Typical Failure Mod

SAMPLE ID	MAXIMUM COMPRESSIVE LOAD (lbf)	DISPLACEMENT AT MAXIMUM LOAD (in.)	FAILURE MODE	RAFTER SPECIFIC GRAVITY	RAFTER MOISTURE CONTENT (%)
C-1	700	2.1	Hook Contact w/ Plywood	0.377	9.2
C-2	780	2.0	Hook Contact w/ Plywood	0.603	9.7
C-3	780	2.2	Hook Contact w/ Plywood	0.500	9.8
C-4	780	2.3	Hook Contact w/ Plywood	0.317	8.4
C-5	765	2.0	Hook Contact w/ Plywood	0.374	9.0
C-6	786	2.1	Hook Contact w/ Plywood	0.522	9.0
AVERAGE	765	2.1	..	0.454	9.2

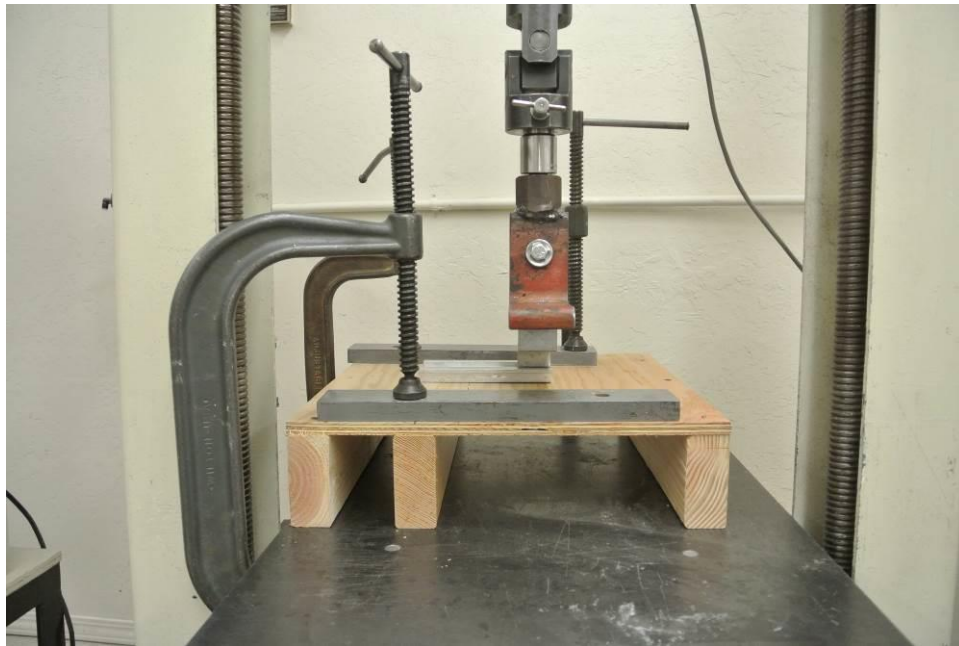
Figure 2a. Test Setup

FIGURE 2
QMSS- 6061 BASE PLATE
TENSIL (UPLIFT) LOAD TEST SETUP
PROJECT NUMBER 114490C

A total of six tests were conducted for tensile load capacity on January 15th, 2015 using a United Universal testing machine. Samples were rigidly attached to the testing machine and an uplift load was applied to the hook. The samples were loaded in tension at a constant rate of axial deformation of 0.09 in./min. without shock until failure occurred; displacement at maximum load was recorded. Based on the above testing, the average maximum tensile load of the QMHSS attached to a 2"x4" Douglas Fir rafter using two 5/16"Ø x 3.5" lag bolts was determined to be 1147 lbf. Detailed results are provided in Table II. Test setup and mode of failure are provided in Appendix B, Figure 2.

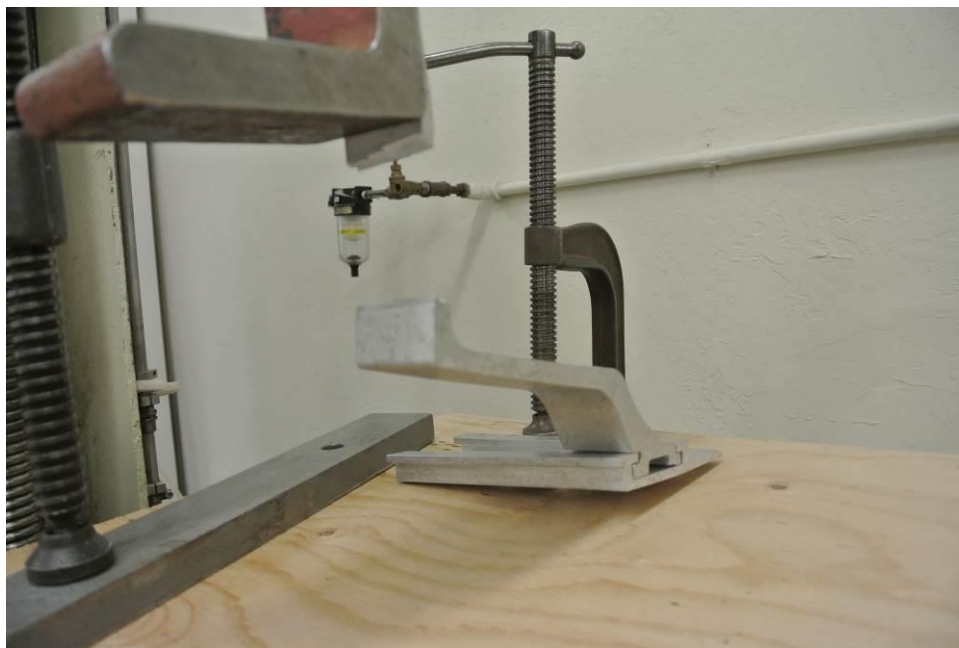
Figure 2b. Typical Failure Mode

SAMPLE ID	MAXIMUM UPLIFT LOAD (lbf)	DISPLACEMENT AT MAXIMUM LOAD (in.)	FAILURE MODE	RAFTER SPECIFIC GRAVITY	RAFTER MOISTURE CONTENT (%)
T-1	1182	3.2	Broken Hook	0.444	7.7
T-2	1175	3.3	Broken Hook	0.476	7.6
T-3	1056	3.0	Broken Hook	0.459	9.4
T-4	1140	3.0	Broken Hook	0.472	7.2
T-5	1164	3.6	Broken Hook	0.444	7.0
T-6	1166	3.1	Broken Hook	0.500	8.5
AVERAGE	1147	3.2	..	0.466	7.9

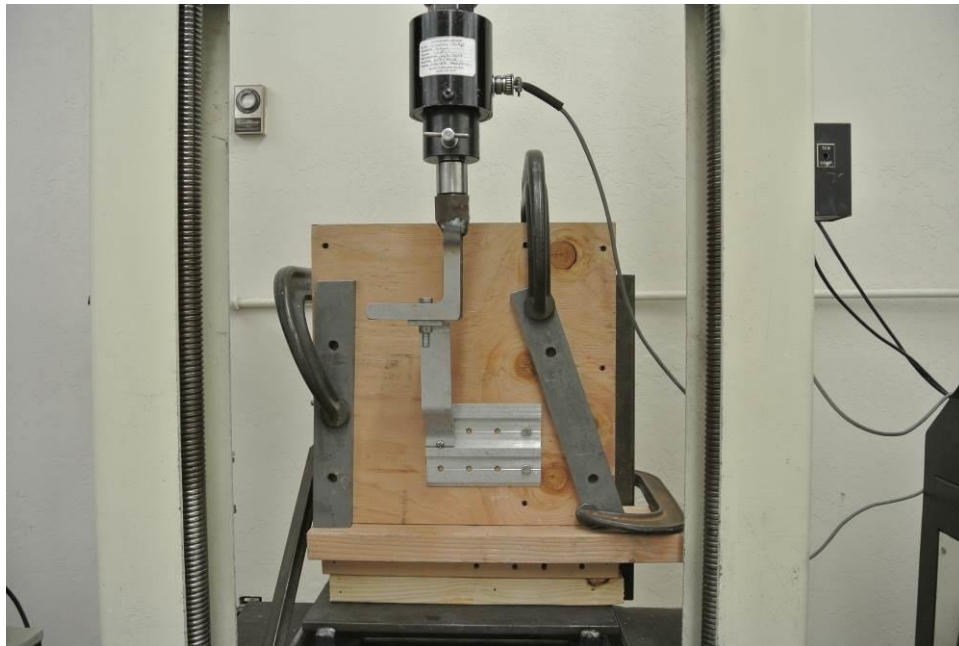
Figure 3a. Test Setup

SHEAR (LATERAL) LOAD TEST PARALLEL TO RAFTER

Six samples were tested for shear strength parallel to rafter on January 21st, 2015 using a United Universal testing machine. Samples were rigidly attached to the testing machine and a shear load was applied to the hook parallel to the rafter. The samples were loaded at a constant rate of axial deformation of 0.09 in./min. without shock until failure occurred. Based on the above testing, the average ultimate load, of the QMHSS attached to a 2"x4" Douglas Fir rafter using two 5/16"Ø x 3.5" lag bolts was determined to be 824lbf. Detailed results are provided in Table III. Test setup and mode of failure are provided in Appendix B, Figure 3.

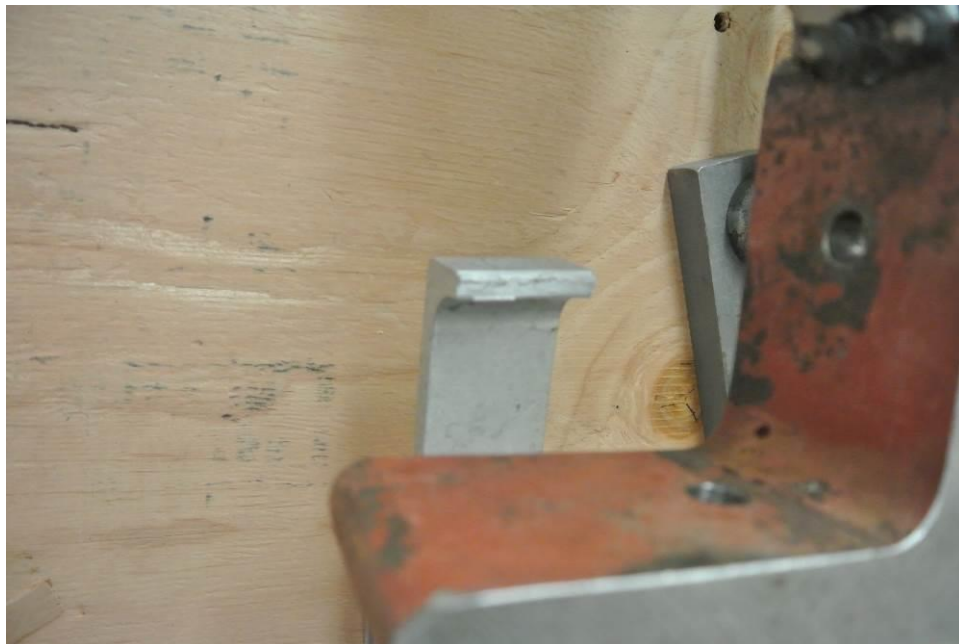
Figure 3b. Typical Failure Mode

SAMPLE ID	MAXIMUM LATERAL LOAD (lbf)	DISPLACEMENT AT MAXIMUM LOAD (in.)	FAILURE MODE	RAFTER SPECIFIC GRAVITY	RAFTER MOISTURE CONTENT (%)
Para-1	787	2.1	Broken Hook	0.481	9.8
Para-2	805	1.4	Broken Hook	0.431	8.7
Para-3	839	1.9	Broken Hook	0.425	8.6
Para-4	834	1.8	Broken Hook	0.520	9.7
Para-5	853	2.0	Broken Hook	0.396	8.4
Para-6	824	1.9	Broken Hook	0.379	8.6
AVERAGE	824	1.9	..	0.439	9.0
